INSTALLATION INSTRUCTIONS

SIDE BAR PART #204009/204009-2
1999 - 2011 CHEVROLET SILVERADO
-GMC SIERRA EXTENDED CAB 2/4WD

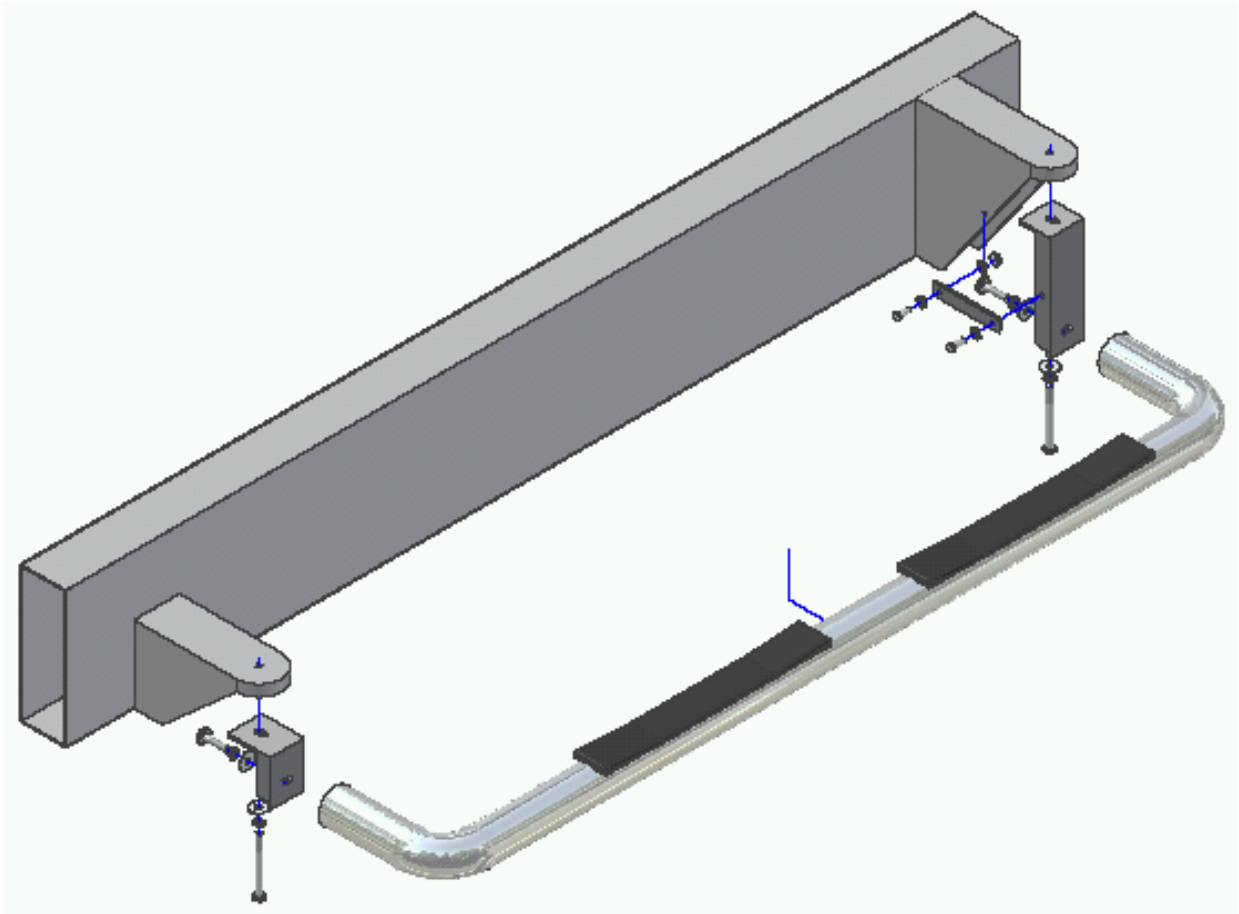
Figure 1.1 – Full Assembly View

1. Begin installation by working on driver side of the vehicle (see Figures 1.1 – 1.3).
2. From underneath truck, loosen and remove body mount bolts that run upward through mounts into floorboard. Attach and secure Front Mount Bracket to underside of vehicles front body mount (see Figure 1.2) with (1) M12 – 1.75 x 120mm bolt, (1) 12mm split lock washer, and (1) 12mm flat washer. Hand Tighten.

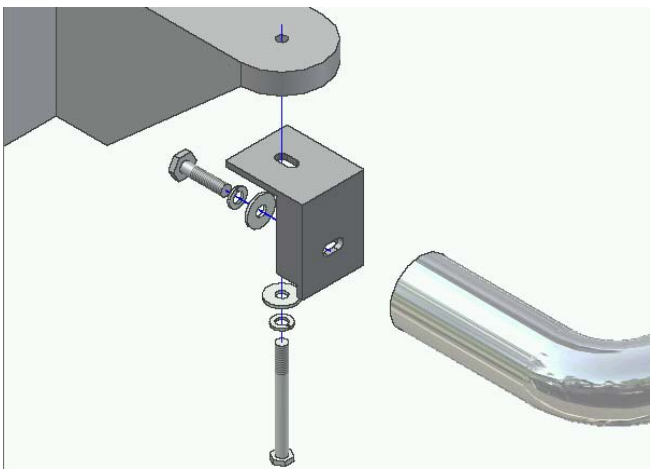
Figure 1.2 – Front Bracket

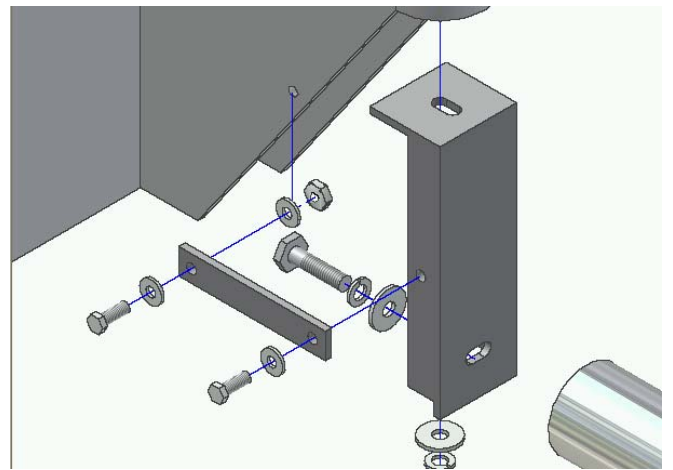
Figure 1.3 – Rear Bracket

3. Attach and secure Rear Mount Bracket to underside of vehicles rear body mount in same manner as the front.
4. Fasten Mount Brace to Rear Mount Bracket and vehicles rear body mount using (1) 10mm x 25mm bolt, (2) 10mm flat washers, 10mm split washer and (1) 10mm hex nut, for each side of Mount Brace (see Figure 1.3). Hand tighten.

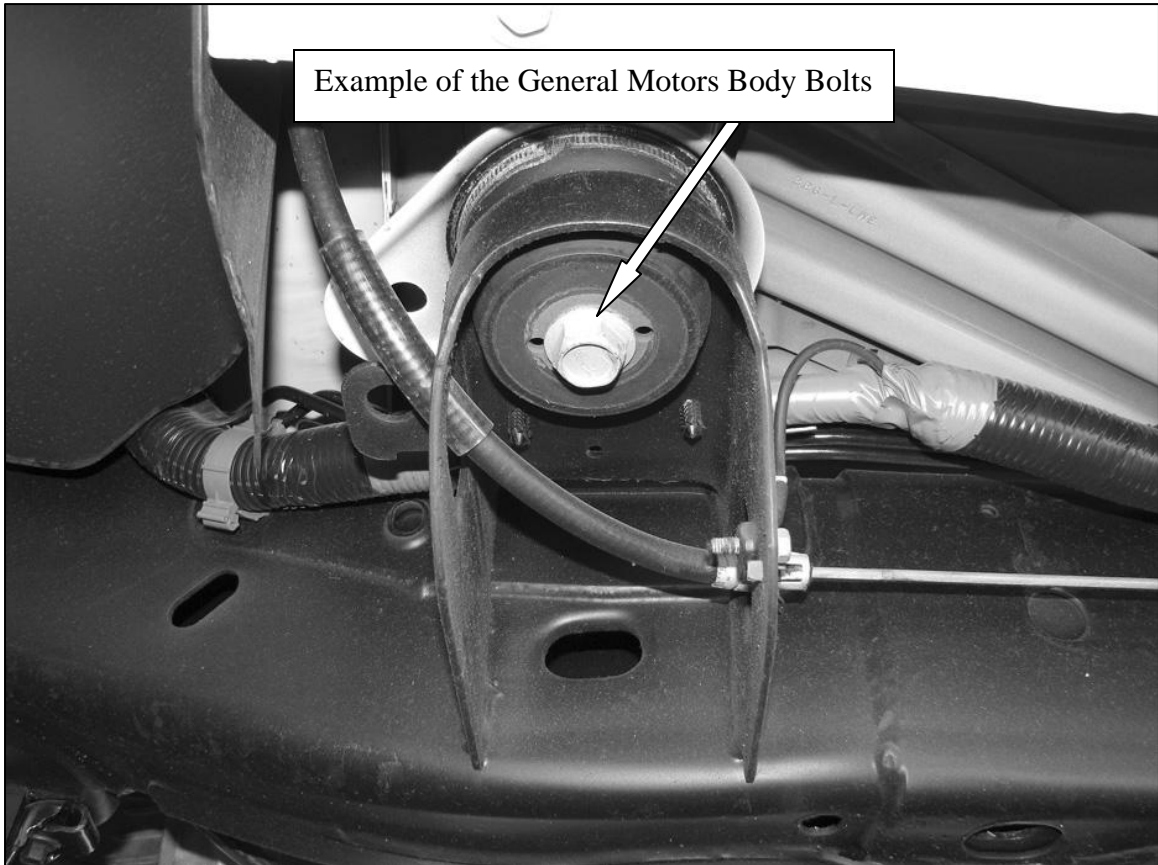
Currently, all Side Bars manufactured for GM trucks use the factory body mount bolts to attach the bars and brackets to the truck. In years past, GM used a fixed nut that was welded in place to the chassis of the truck. Starting late 2010, GM has now gone to a loose nut that is surrounded by a "Cage Nut" which has two tabs on either side of the nut to keep it from loosening. Along with this cage nut, GM is also using Heavy Duty Loc-tite on the Body Mount Bolts for added protection.

Due to this change, Aries is recommending **EXTREME CARE** when removing the factory body mount bolts from these trucks. **Loosen and re-tighten all body mount bolts by hand! DO NOT use Impact Tools of any kind!** If bolts become increasingly tight as you are loosening them you may need to retighten & loosen the bolt several times to clear the loc-tite from the threads Failure to follow this instruction could cause the body mount bolts to seize and the tabs of the 'Cage Nut' to bend allowing the nut to spin freely inside Chassis floor board!
